**California Department of Fish and Game
San Francisco Bay East Marin Watersheds
Stream Habitat Assessment Reports**

**Arroyo Corte Madera
del Presidio**

STREAM INVENTORY REPORT

Survey Conducted Summer 2009

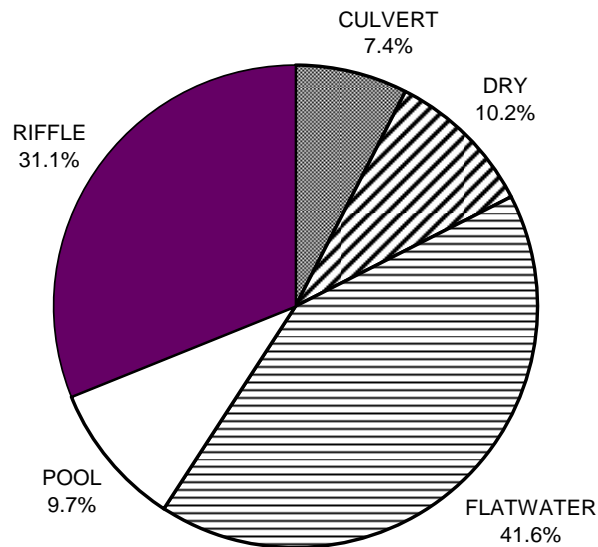
GRAPH 2

Table 1 summarizes the Level II riffle, flatwater, and pool habitat types. Based on frequency of occurrence there were 34% flatwater units, 15% pool units, 29% riffle units, 17% culvert units, and 5% dry units (Graph 1). Based on total length of Level II habitat types there were 42% flatwater units, 10% pool units, 31% riffle units, 7% culvert units, and 10% dry units (Graph 2).

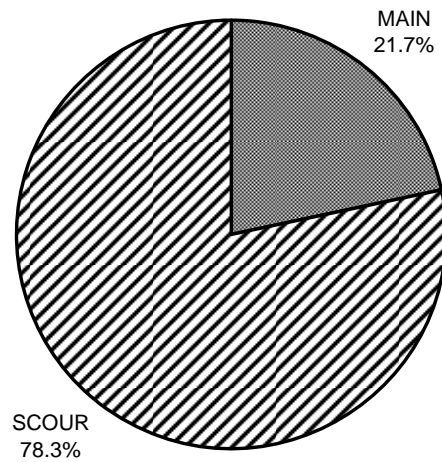
GRAPH 4

A total of 46 pools were identified (Table 3). Scour pools were the most frequently encountered, at 78%, and comprised 74% of the total length of all pools (Graph 4).

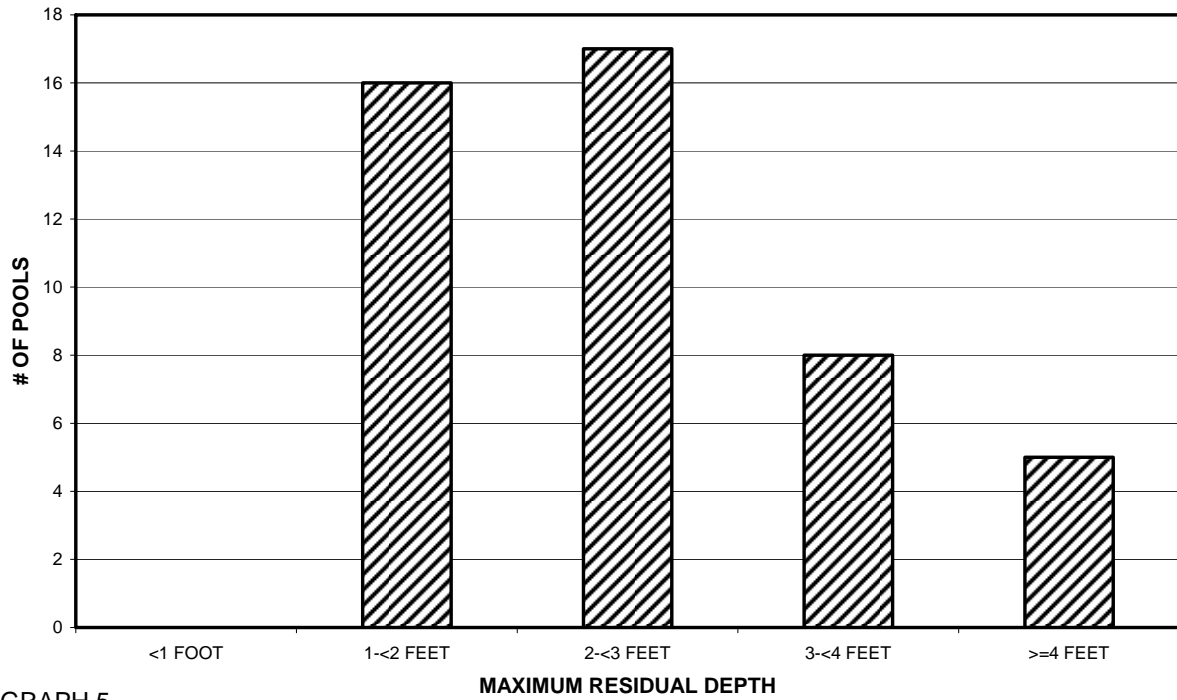
GRAPH 5

Table 4 is a summary of maximum residual pool depths by pool habitat types. Pool quality for salmonids increases with depth. Thirty of the 46 pools (65%) had a residual depth of two feet or greater (Graph 5).

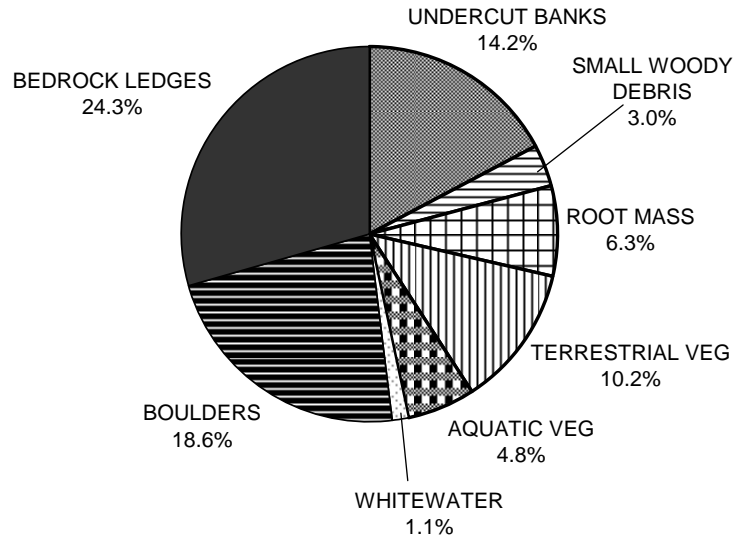
GRAPH 7

Table 5 summarizes mean percent cover by habitat type. Bedrock Ledges are the dominant cover types in Arroyo Corte Madera del Presidio. Graph 7 describes the pool cover in Arroyo Corte Madera del Presidio. Bedrock Ledges are the dominant pool cover type followed by boulders.

- 2) Increase woody cover in the pools and flatwater habitat units. Most of the existing cover in the pools is from Boulders. Adding high quality complexity with woody cover in the pools is desirable.

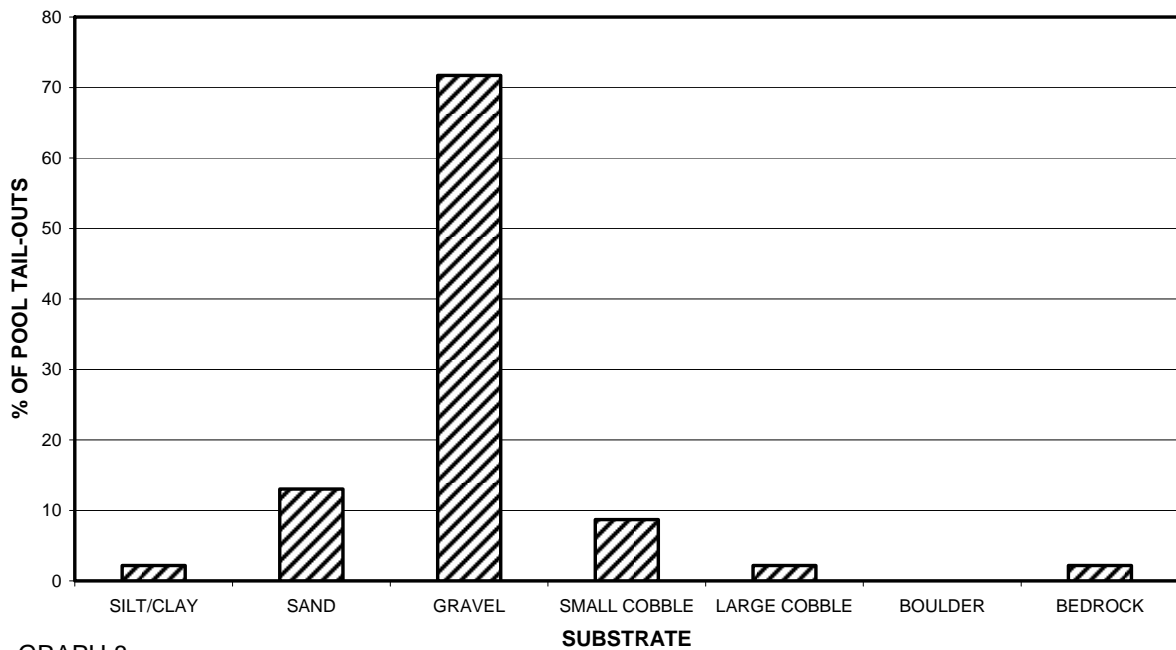
GRAPH 8

Table 6 summarizes the dominant substrate by habitat type. Graph 8 depicts the dominant substrate observed in pool tail-outs. Sand dominance was observed in 13% of pool tail-outs, and gravel dominance was observed in 72% of pool tail-outs.

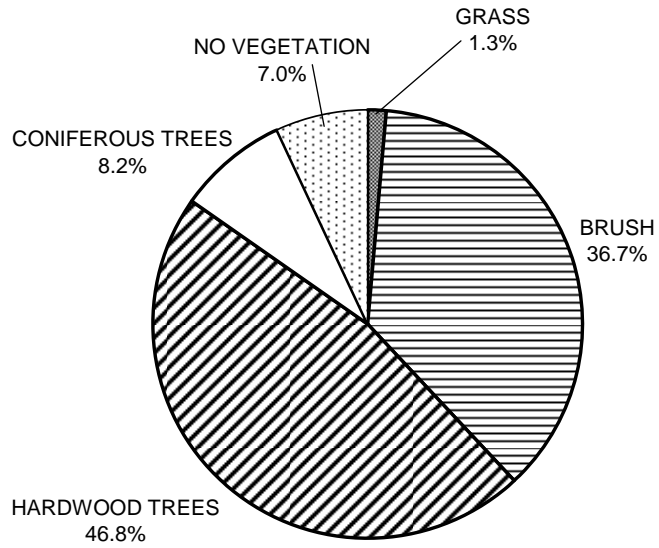
GRAPH 11

For the stream reach surveyed, the mean percent right bank vegetated was 57%. The mean percent left bank vegetated was 50%. The dominant elements composing the structure of the stream banks consisted of 39% bedrock, 8% boulder, 8% cobble/gravel, and 44% sand/silt/clay (Graph 10). Hardwood trees were the dominant vegetation type observed in 47% of the units surveyed. Additionally, 37% of the units surveyed had brush as the dominant vegetation type, and 8% had coniferous trees as the dominant vegetation (Graph 11).
